# **The Road Inventory of Deer Flat National Wildlife Refuge Nampa, ID**

Prepared By:  
Federal Highway Administration  
Central Federal Lands Highway Division  
April 2013

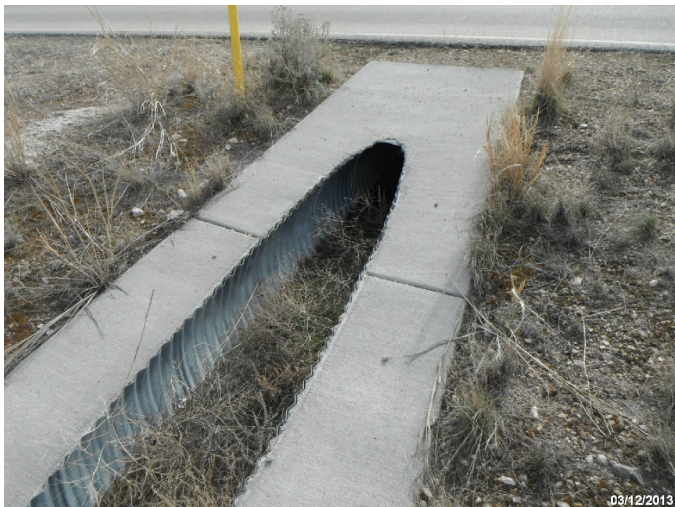
Photo: DEFL\_C4\_0116 Route: 011-001-0.31  
Metal Culvert 50ft long 24in dia. 1ft deep

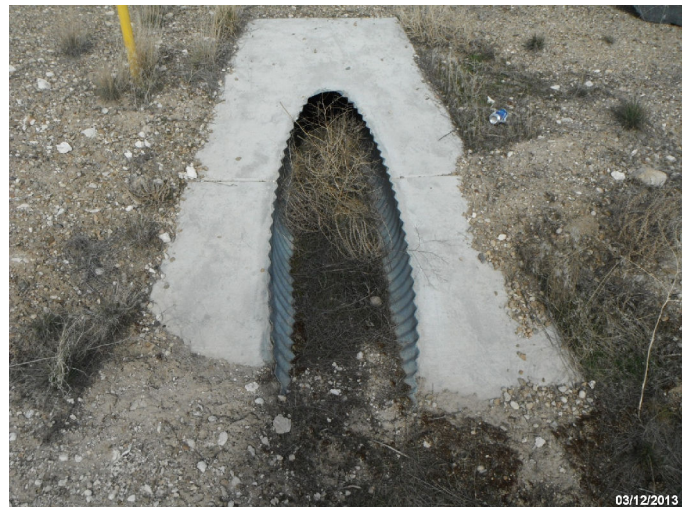
Photo: DEFL\_C4\_0117 Route: 011-001-0.31  
Metal Culvert 50ft long 24in dia. 1ft deep

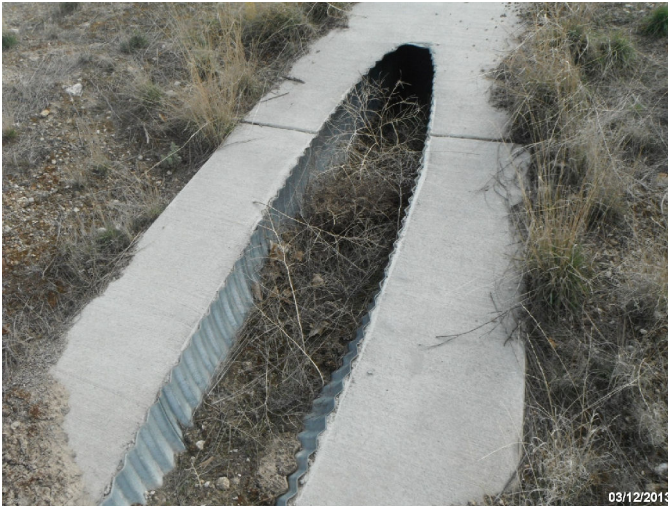
Photo: DEFL\_C4\_0118 Route: 011-001-0.42  
Metal Culvert 50ft long 24in dia. 2ft deep

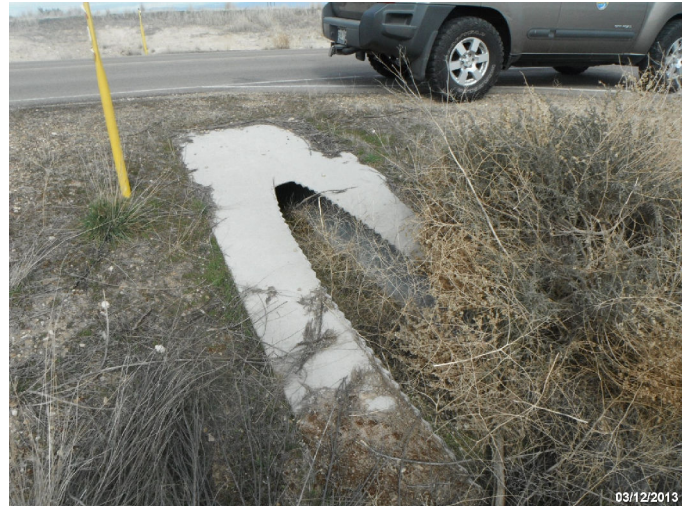
Photo: DEFL\_C4\_0119 Route: 011-001-0.42  
Metal Culvert 50ft long 24in dia. 2ft deep

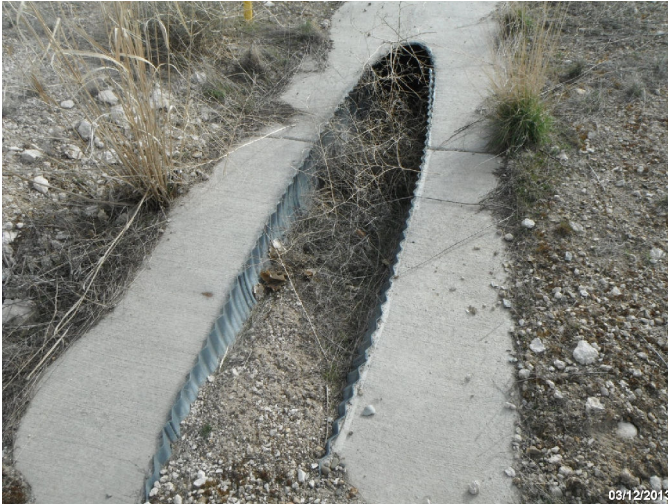
Photo: DEFL\_C4\_0120 Route: 011-001-0.51  
Metal Culvert 55ft long 24in dia. 2ft deep

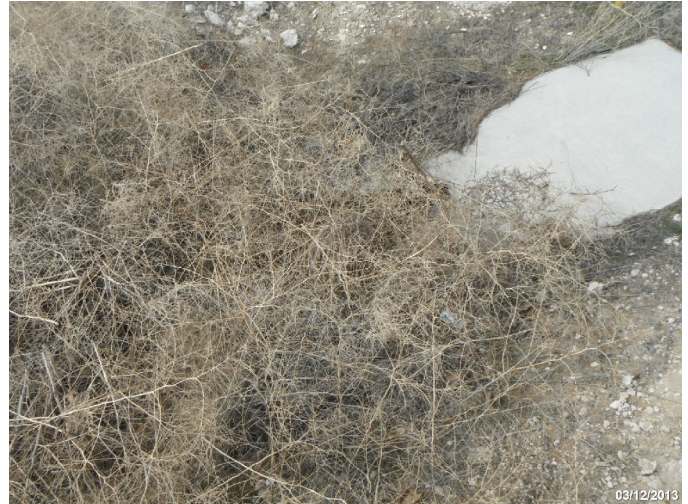
Photo: DEFL\_C4\_0121 Route: 011-001-0.51  
Metal Culvert 55ft long 24in dia. 2ft deep

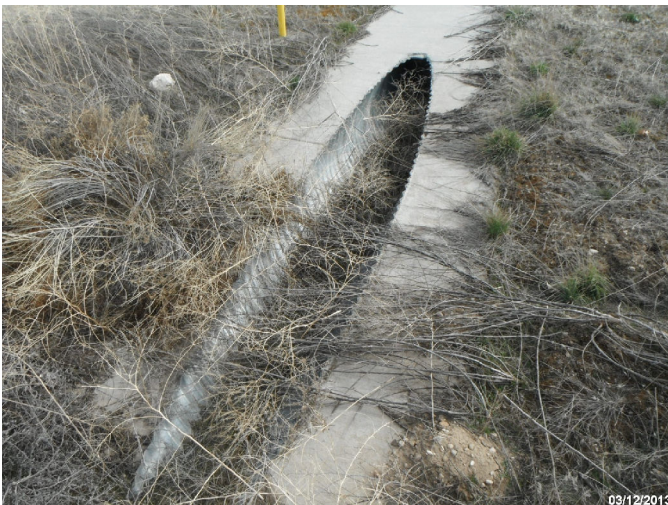
Photo: DEFL\_C4\_0122 Route: 011-001-0.59  
Metal Culvert 55ft long 24in dia. 2ft deep

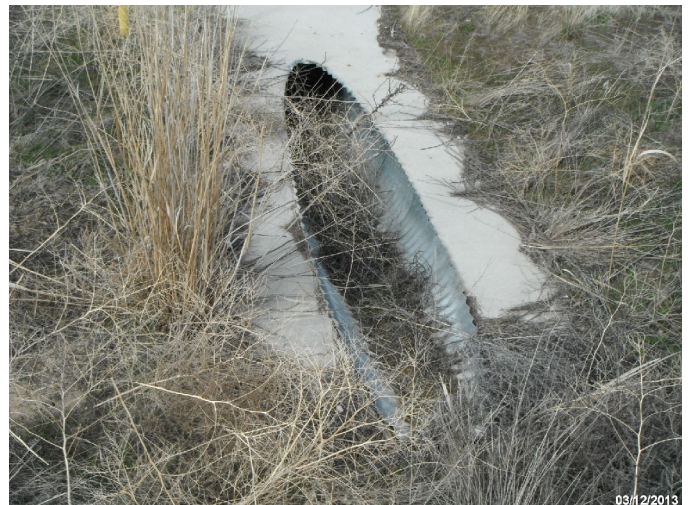
Photo: DEFL\_C4\_0123 Route: 011-001-0.59  
Metal Culvert 55ft long 24in dia. 2ft deep

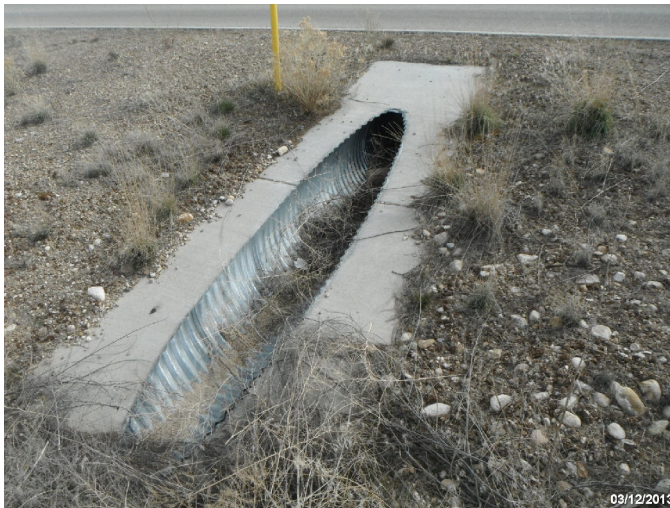
Photo: DEFL\_C4\_0124 Route: 011-001-0.61  
Metal Culvert 55ft long 24in dia. 2ft deep

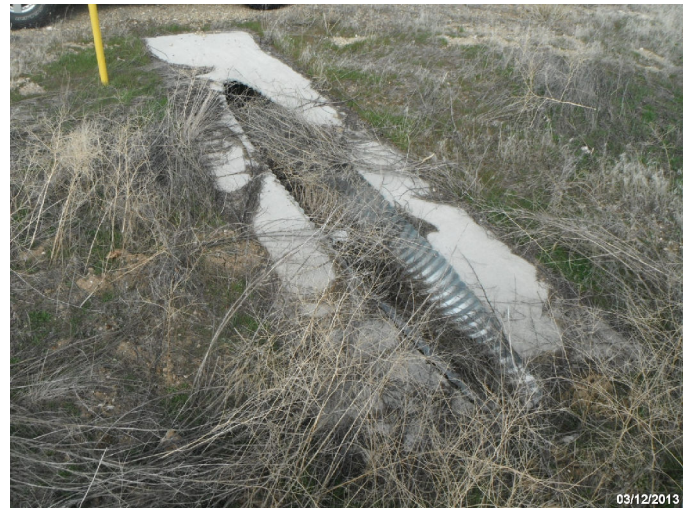
Photo: DEFL\_C4\_0125 Route: 011-001-0.61  
Metal Culvert 55ft long 24in dia. 2ft deep

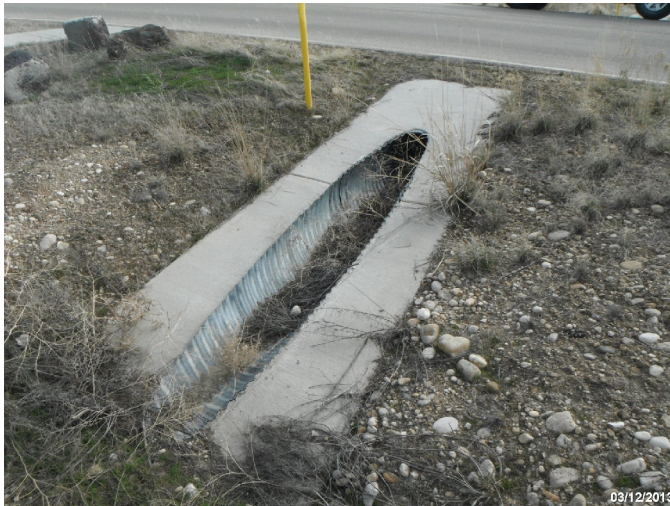
Photo: DEFL\_C4\_0126 Route: 011-001-0.7  
Metal Culvert 55ft long 24in dia. 2ft deep

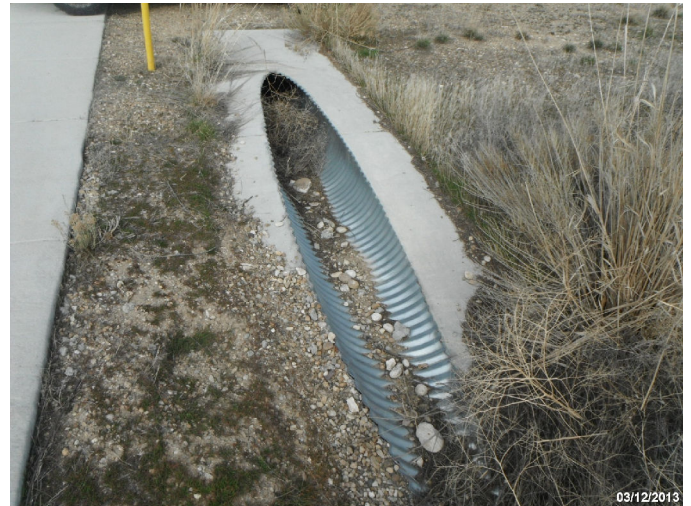
Photo: DEFL\_C4\_0127 Route: 011-001-0.7  
Metal Culvert 55ft long 24in dia. 2ft deep

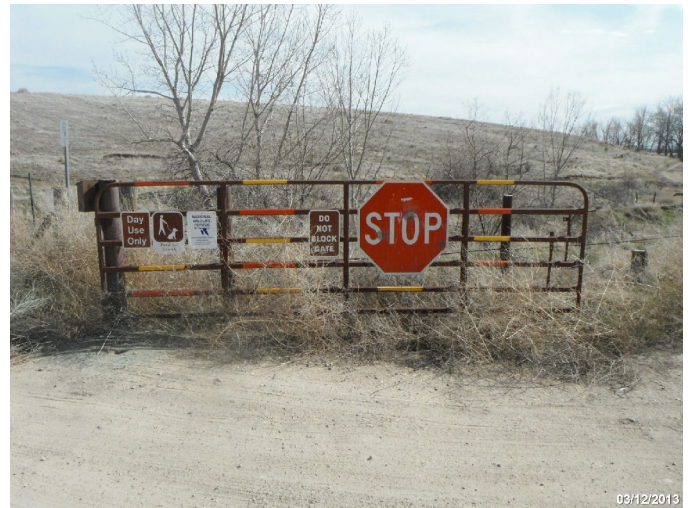
Photo: DEFL\_C4\_0088 Route: 100-001-0.0  
Metal Open Rail Gate

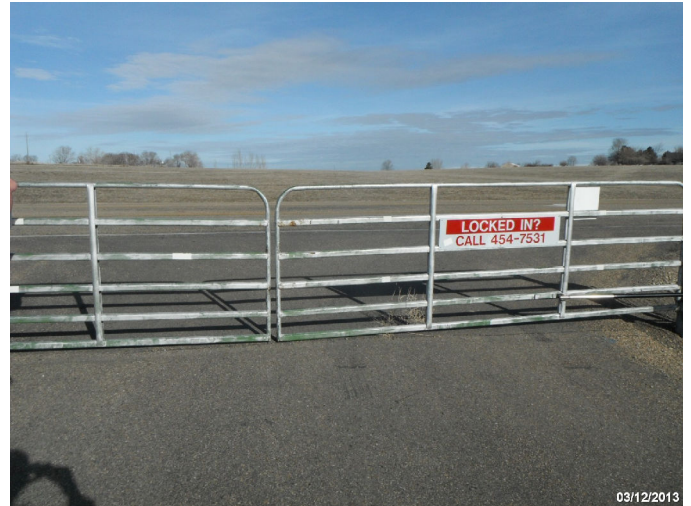
Photo: DEFL\_C4\_0005 Route: 101-001-0.0  
Metal Open Rail Gate electric

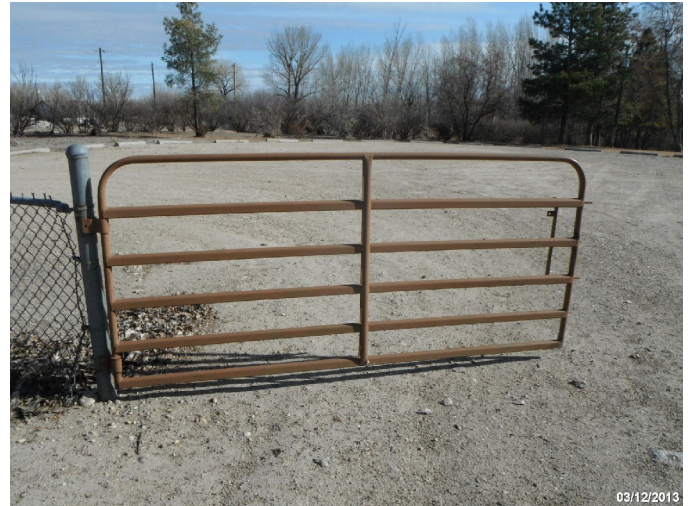
Photo: DEFL\_C4\_0009 Route: 102-001-0.28  
Metal Open Rail Gate

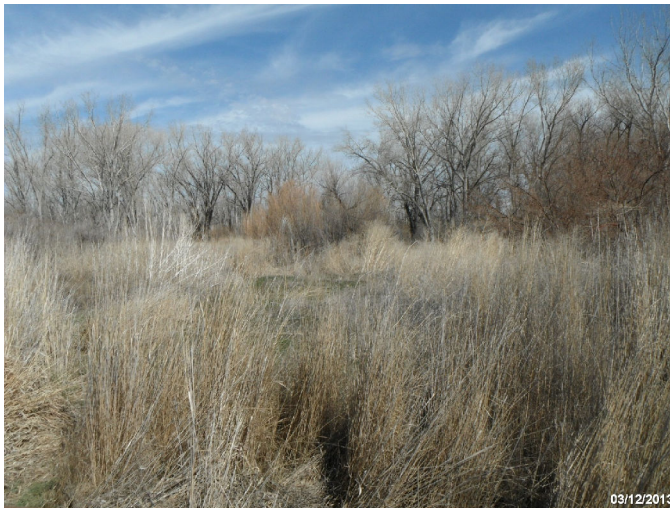
Photo: DEFL\_C4\_0045 Route: 600-001-0.0  
Obstacle Location of Carter's Corner East Road.  
Asset# 100435311. Too overgrown to drive
